# **SEAT Leon** 5-door (from 2020)

# **SEAT Leon**

# 5-door (from 2020)

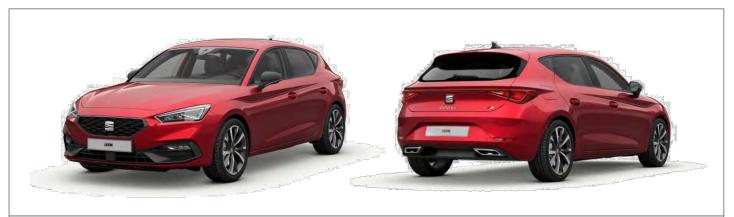
**Information:** the complete equipment which is to be fitted is shown.

Airbag		Gas generator	Belt tensioner	SRS control unit		Active pedestrian protection system
1	Automatic rollover support system		Gas strut / pre- tensioned spring	High-strength area	Special attention		
000 000	Low-voltage battery	H	Low-voltage ultra- condenser	Fuel tank	Gas tank		Safety valve
0 0	High-voltage battery	2	High-voltage cables	High-voltage device to the high-voltage shutdown system	Fuse box Deactivation High-voltage system	4	High-voltage super-condenser
