(5-door hatchback, 2023-)

1. Introduction / recognition

Rescue sheet_BYD DOLPHIN_001_en

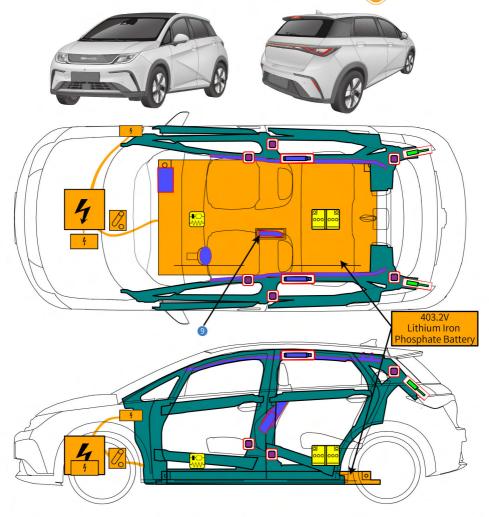
Airbag		Stored gas inflator		Seat belt pretensioner
	Gas strut/Preloaded spring		High strength zone		SRS control unit
000 000	Battery low voltage	N	High voltage power cable	4	High voltage component
	Battery pack, high-voltage	%	High voltage device that disconnects high voltage

Driver's seat has a far side airbag in addition to the side airbag. Location of far side airbag is shown in the mark 19 on page 1.
